RE: Site Inspection, Scott Higley, 2 More Feet, S/013/007, Duchesne County, Utah

# 2 More Feet S/013/007 and Moore & Crook E/051/006

**Photographs**

**S/013/007, 2 More Feet, Scott Higley**

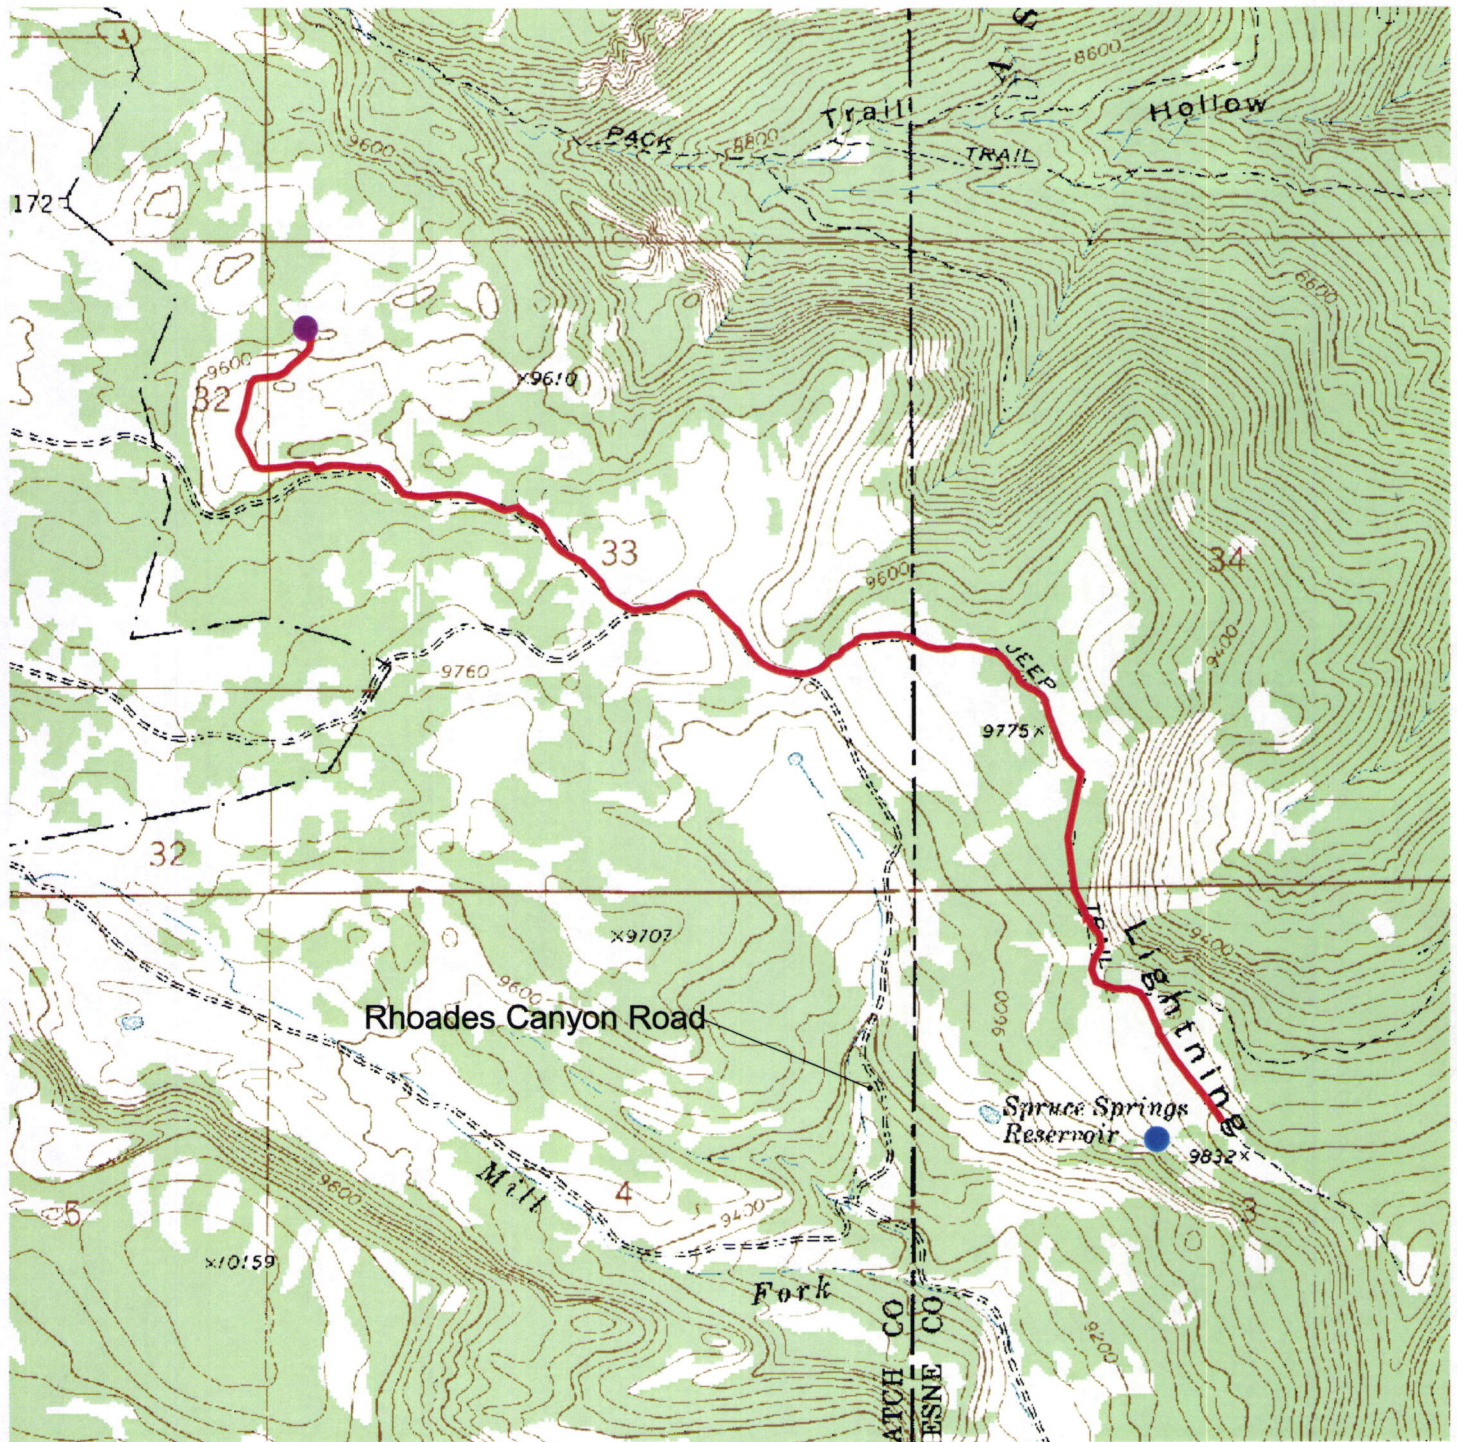
Denny Moore and 2 More Feet sites and the road between them. Map created 7/17/03 from GPS data collected 7/14/03 by Paul Baker. Sect. 33, Township 1 North, Range 9 West, USM. Iron Mine Mountain Quad. This map may not meet Division standards for accuracy and content. Different data sources and input scales may cause some misalignment of data layers.

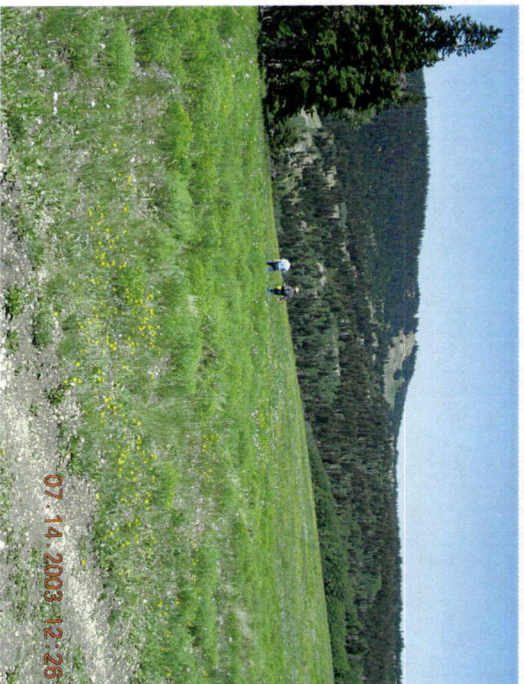
**Photo 3. Walking down toward the mine from the road on Lightning Ridge.**

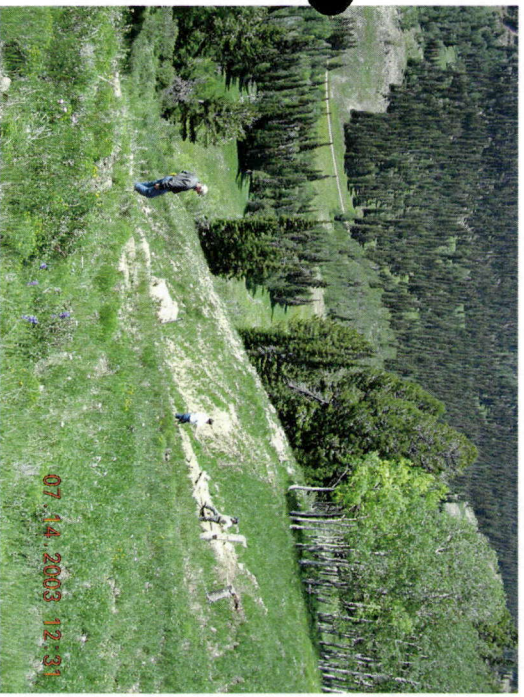
**Photo 2. The mine is at the right center of the photo just after the hill steepens. Note the Rhoades Canyon road in the bottom of the canyon.**

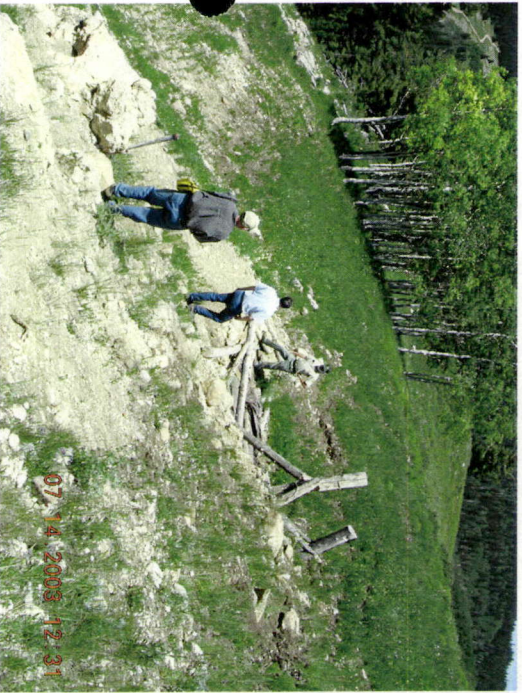
Disturbance at the 2 More Feet site is probably less than a thousand square feet. There is one shaft with some log supports and a tarp over the opening. There is a hole about two feet deep with a false dirt floor which I understand from the operator is over an 8-foot shaft.

Vegetation near the mine is a green rabbitbrush meadow community. Surrounding areas have aspens, Engelmann spruce, and subalpine fir. As can be seen in Photos 5 and 6, there are some bare areas adjacent to the mine.

Photo 5. The 2 More Feet Mine.

Mr. Higley also described a metal cage he plans to install. As I understood it, this cage would be put in the shaft and would extend far enough above the surface to hold rock and soil above the mine. Putting material above the opening will make the area much easier to reclaim. The top of this cage could be closed to discourage anyone from going in the shaft.

If any waste or other material is put on the hill below the mine, there will need to be some kind of retaining wall to keep it from going down the side of the canyon.

Seed should be broadcast in the fall and should be raked into the soil. On this steep slope, the Division recommends also applying some certified noxious weed free mulch, such as straw, to help protect the seed and the soil.

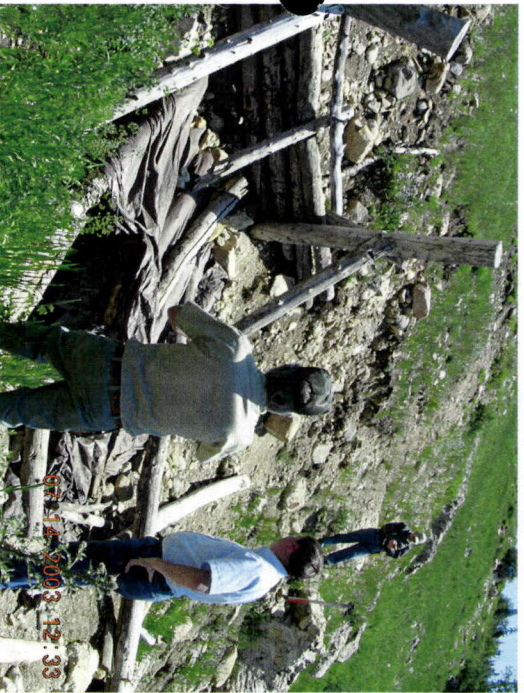
Photo 6. Another view of the 2 More Feet Mine.
